Manhole Inspection Summary

Manhole # S37E__047MH

Location Address: **201 e lexington st**

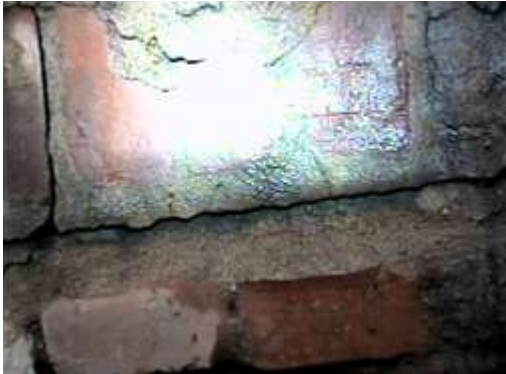
Defect 2

Condition: ☐ Sound ☒ **Cracked** ☐ Root Intrusion ☐ Loose Brick ☐ Deteriorated

crack in frame adj

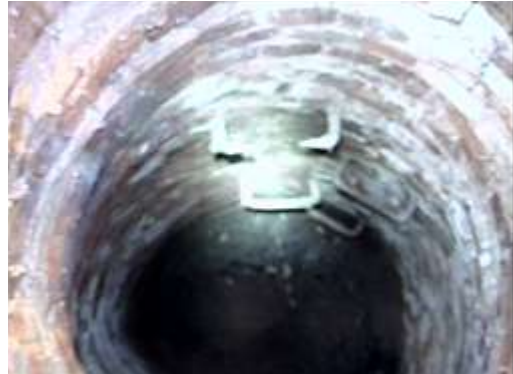
Defect 1

Count: **4** Missing: **1** ☒ **Corroded**

steps corroded

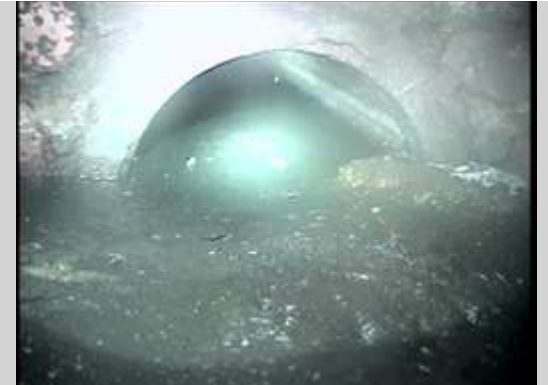
12 O'Clock Outflow

8 in. Circular Gravity Sewer
Pipe Out @ 12 O'Clock

Invert Depth: **8.83** (ft.) Flow Characteristics: **None**

Infiltration: **None** Pipe Seal Cond: **Unknown**
